**Research/Technical Note**

# A Useful Technique for Removing a Broken Guide-wire in the Femoral Neck Through the Proximal Femoral Nail Hole During Operation

**To cite this article:**Wenrui Wu, Simin Luo, Tengfeng Zhuang, Ning Liu, Zhengang Zha. A Useful Technique for Removing a Broken Guide-wire in the Femoral Neck Through the Proximal Femoral Nail Hole During Operation. *Journal of Surgery*. Vol. 7, No. 5, 2019, pp. 128-131.

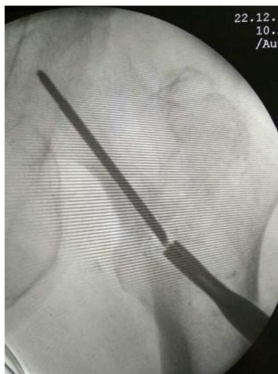
Figure 1. Broken pin in a 71-year-old patient at the time of reaming.

intertrochanteric fracture was performed under a C-arm X-ray Machine. The surgeon performed a standard skin incision about 5 cm proximal from the tip of the greater trochanter and exposed. Then, the entry point was made. The guide wire was passed through and reaming of the canal by the rod. After reaming, assemble PFNA instruments, a proximal femoral nail with appropriate size and diameter was inserted easily. Choose aiming arm for PFNA blade insertion and prepare guide-wire insertion, position guide-wire with aiming device and insert it. However, when the cannulated reamer through the neck to the head of the femur, a sudden loss of resistance was unexpectedly encountered. On checking under a C-arm image intensifier showed that the guide-wire was broken about 5 cm from the threaded end. In one case the broken guide-wire had not breached the hip joint, just touching the articular surface of the femoral head. In the other case the broken guide-wire was just protrusion into the hip joint. The surgeon therefore decided to remove it.

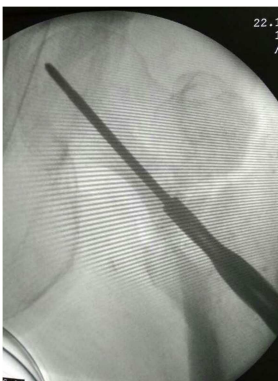
Figure 2. Confirm the cannulated reamer to sight the broken end of the wire.

We tried to use the Kocher forceps and Kerrison/pituitary rongeur to remove the broken pin. The both above method for removing the broken guide-wire were failed. Ultimately, we used the original cannulated reamer to ream over the guide wire under the C-arm image intensifier. At first, confirm the cannulated reamer to sight the broken end of the wire, and passed through the broken guide-wire in both image planes. Then, the reamer was advanced further reaming with low speed rotation till the beginning of the reamer encased the broken guide-wire. Afterwards, the reamer was withdrawn a few millimeters, compared anteroposterior and lateral view with all the previous images to confirm dislodgment of the guide-wire from its original position. After confirmation of the broken guide-wire dislodgment and firmly engaged within the drill lumen. Reverse the guide-wire slightly with the reamer from the bone. C-arm image intensifier confirmed complete removal of the guide-wire fragment. The PFNA blade was inserted in its original track and distal locking to complete the procedure. The screw purchase was found to be satisfactory.

The operator only needs to continue the original operation procedures. Put the original cannulated reamer into the screw hole, confirm the reamer to sight the broken end of the wire, and pass through the broken guide-wire under a C-arm image intensifier in both anteroposterior and lateral views. Because the cross-sectional shape of the pin changes to an oval rather than a round shape at the point of the break, reaming with a cannulated reamer engages the pin, allowing the pin to be removed easily [14]. Generally speaking, once the threads were engaged the broken piece of wire was easily removed by withdrawing the reamer. After our experience with the first patient, in the other 2 cases we used an original cannulated reamer to avoid any extensive reaming and trauma to the tissues. With this method, we were able to remove the broken pin easily in a few minutes.

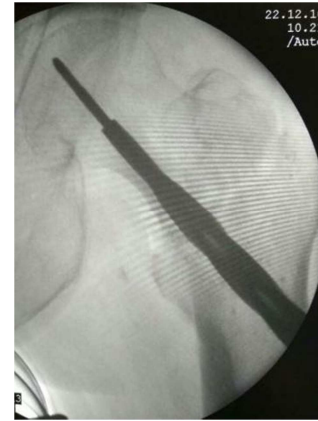
Figure 3. The reamer is passed through the broken guide-wire under the C-arm image intensifier.

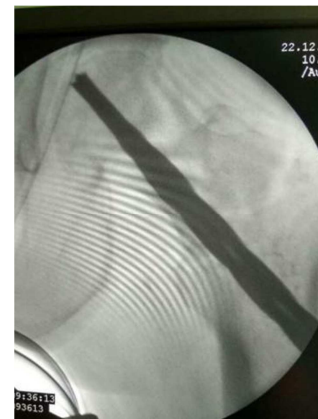
Figure 4. The reamer was advanced further reaming till its encased a large portion of the broken guide-wire. Afterwards, reverse the guide-wire with the reamer from the bone.

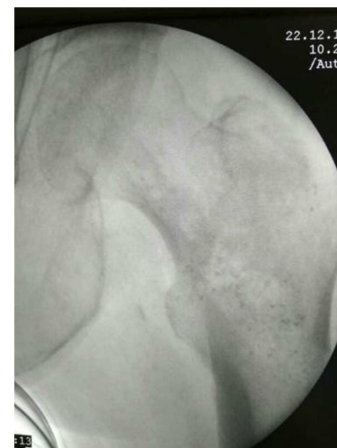
Figure 5. The broken pin is complete removed by a cannulated instrument.

The idea came out during our ordinary practice, sometimes the guide-wire may along with the reamer when withdraw the cannulated reamer. The guide-wire sometimes trapped, together with bone debris, within the lumen of the cannulated reamer, This was perhaps the reason why we could use the cannulated reamer to retrieve the broken guide-wire, and it also can use a cannulated drill bit to retrieve the broken guide-wire.

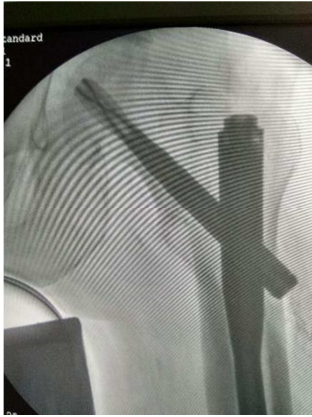
**Figure 6.** The PFNA blade was inserted in its original track to complete the procedure.
